# PHYSICAL NEEDS ASSESSMENT

**Tacoma Housing Authority**  
902 South L Street  
Suite 2A  
Tacoma, WA 98405-4307  
Ginger Peck

North Highland Court Apartments  
3105 North Highland Street  
Tacoma, WA 98407

*June 23, 2023*

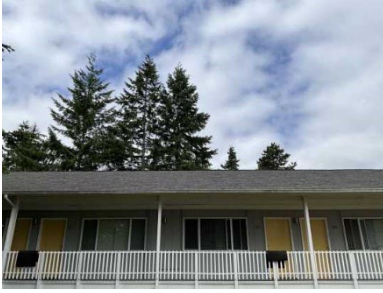
### Roofing in Poor condition.

Asphalt Shingle, 30-Year Premium  
North Highland Court Apartments Roof

Past the RUL - AssetCALC ID: 6721445

Uniformat Code: B3010  
Recommendation: **Replace in 2024**

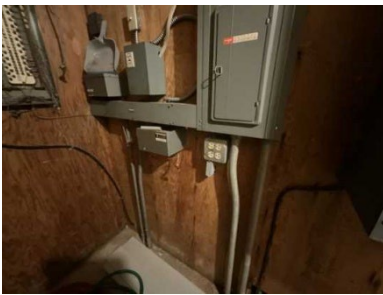
### Electrical System in Poor condition.

Wiring & Switches, Average or Low  
Density/Complexity  
North Highland Court Apartments Throughout  
building

Update electrical infrastructure. Original to building construction. - AssetCALC ID: 6721452

Uniformat Code: D5030  
Recommendation: **Replace in 2024**

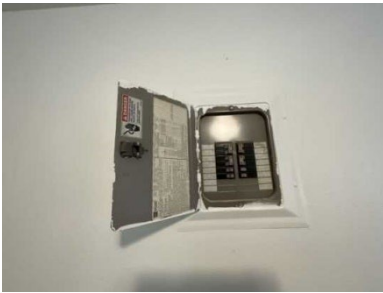
### Distribution Panel in Poor condition.

120/240 V, Residential Style  
North Highland Court Apartments Throughout  
building

Original panel, outdated. Phase I - AssetCALC ID: 6721464

Uniformat Code: D5020  
Recommendation: **Replace in 2023**

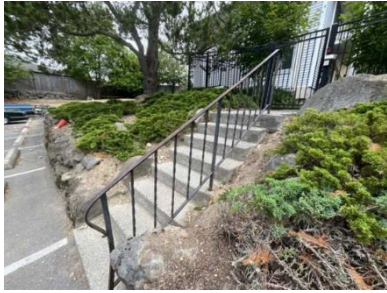
### Stair/Ramp Rails in Poor condition.

Metal  
North Highland Court Apartments Site

Paint has worn exposing rusted metal - AssetCALC ID: 6721462

Uniformat Code: B1080  
Recommendation: **Refinish in 2024**

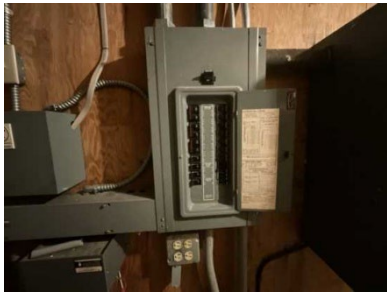
### Distribution Panel in Poor condition.

120/240 V  
North Highland Court Apartments Storage room

Outdated electrical. Original to building construction - AssetCALC ID: 6721448

Uniformat Code: D5020  
Recommendation: **Replace in 2024**

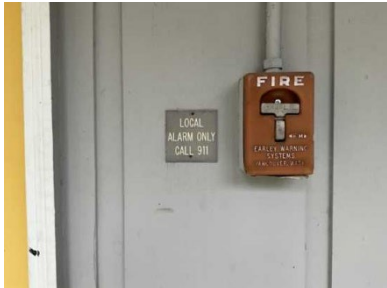
### Fire Alarm System in Poor condition.

Full System Upgrade, Simple Addressable  
North Highland Court Apartments Throughout building

Updates are needed for the fire alarm system. Some components are original to the building. - AssetCALC ID: 6721447

Uniformat Code: D7050  
Recommendation: **Upgrade/Install in 2024**

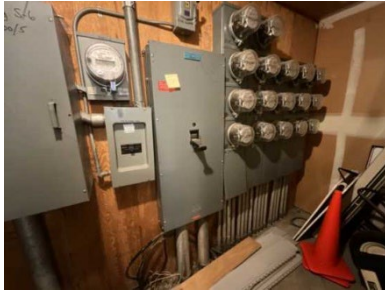
## Supplemental Components in Poor condition.

Circuit Breaker/Disconnect  
North Highland Court Apartments Electrical room

Equipment is outdated. Original to building construction. - AssetCALC ID: 6721466

Uniformat Code: D5020  
Recommendation: **Replace in 2024**
