# PHYSICAL NEEDS ASSESSMENT

**Tacoma Housing Authority**  
902 South L Street  
Suite 2A  
Tacoma, WA 98405-4307  
Ginger Peck

North Highland Court Apartments  
3105 North Highland Street  
Tacoma, WA 98407

*June 23, 2023*

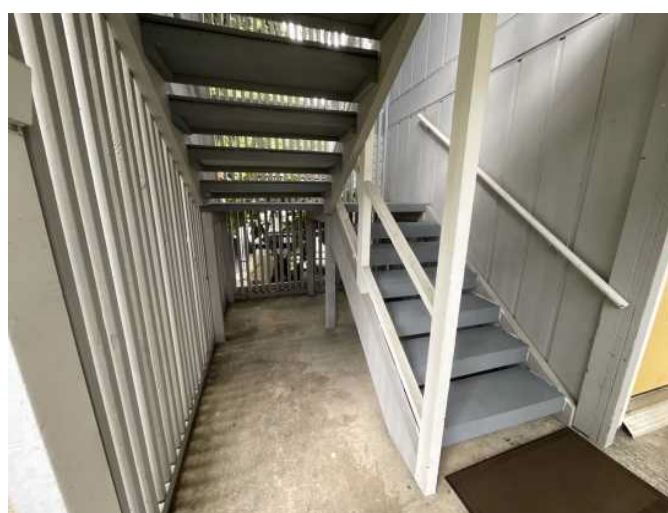
6 - STAIR/RAMP RAILS

### Stair/Ramp Rails in Poor condition.

Paint has worn exposing rusted metal - AssetCALC ID: 6721462

Uniformat Code: B1080  
Recommendation: **Refinish in 2024**

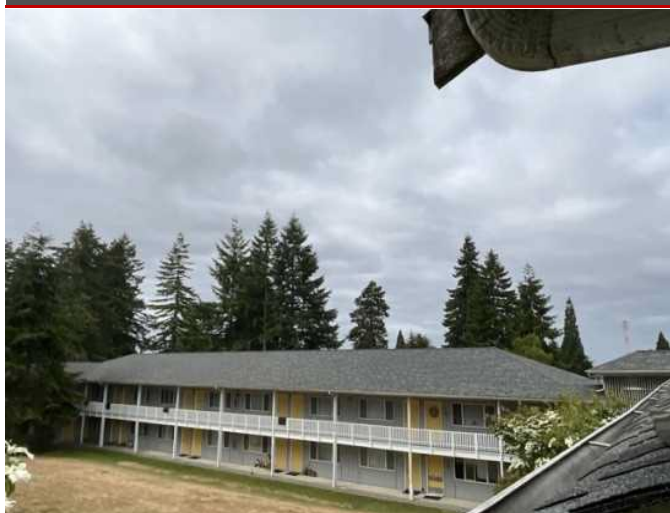
7 - PRIMARY ROOF OVERVIEW

### Roofing in Poor condition.

The roof is in poor condition with leaks reported throughout, the electrical system and panels appear to be original to the 1968 construction, the plumbing sanitary and supply system has frequent clogging, the exterior site stair railing needs to be refinished, the fire alarm system reportedly has frequent failures and some components are out of date.

Uniformat Code: B3010  
Recommendation: **Replace in 2024**

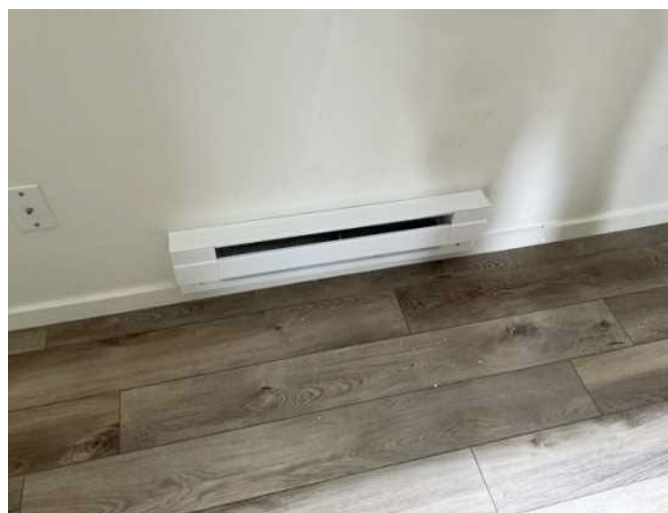
16 - BASEBOARD HEATER

Heating is provided via electric baseboard heaters which are nearing the end of their useful life and should be replaced in the near term. No cooling is provided. Domestic hot water is provided by electric water heaters located in the units utility closets. The electric panels appear to be original and are beginning to fail. They should be replaced soon. The fire alarm system is antiquated and should be modernized in the near term. Overall, the MEPF infrastructure itself is generally in good working condition with no major expenditures anticipated in the short term.

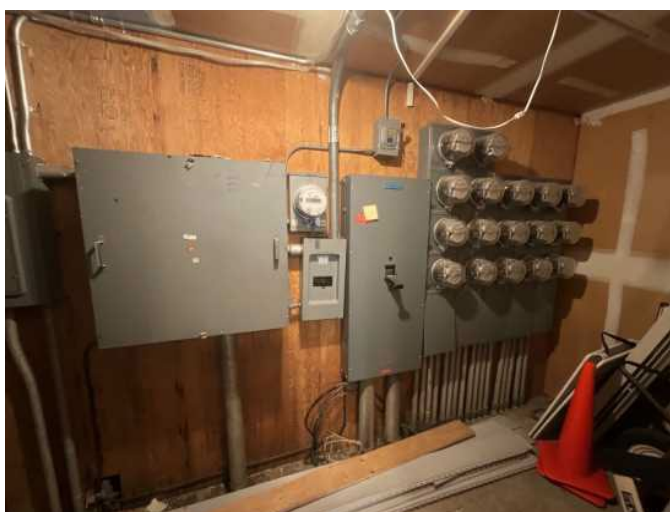
17 - MAIN ELECTRICAL ROOM

### Electrical System in Poor condition.

Uniformat Code: D5030  
Recommendation: **Replace in 2024**

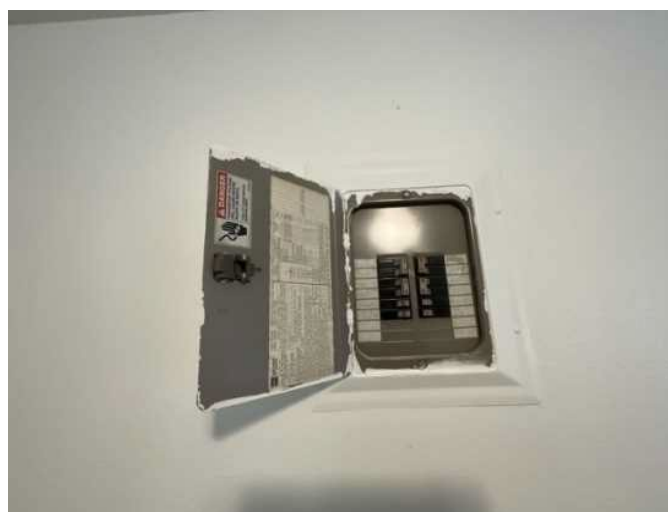
18 - DISTRIBUTION PANEL

### Distribution Panel in Poor condition.

Uniformat Code: D5020  
Recommendation: **Replace in 2023**

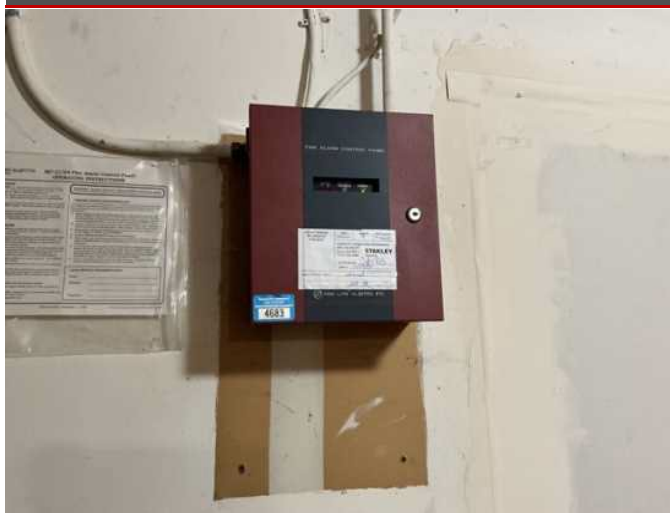
19 - FIRE ALARM PANEL

### Fire Alarm System in Poor condition.

Uniformat Code: D7050  
Recommendation: **Upgrade/Install in 2024**

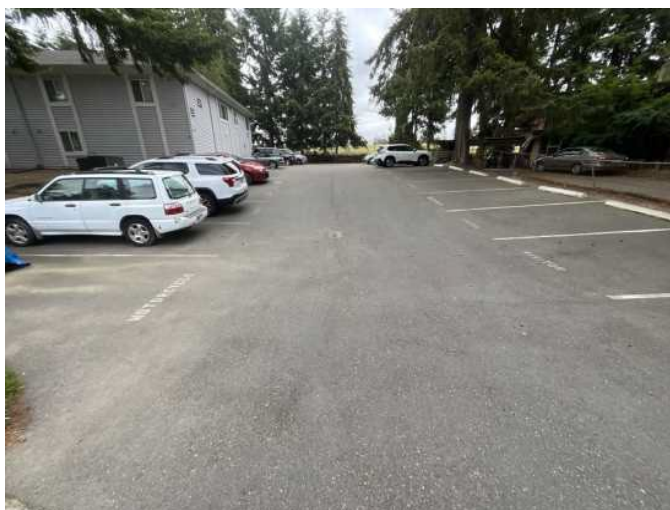
23 - MAIN PARKING AREA

There is major water seepage in the parking lot causing damage to the asphalt parking surface. A professional engineer should be brought in to determine the cause of the problem, and to recommend additional corrective action. A cost for the study is included, but no cost for the repairs are included, due to the ambiguity of the repairs.

Uniformat Code: P2030  
Recommendation: **Evaluate/Report in 2023**
